Life Extension of Dynamic Flexible Risers A Case Study

Damir Tadjiev
Wood Group Kenny, Aberdeen (UK)

Pipeline Design and Integrity Seminar
17 June 2015

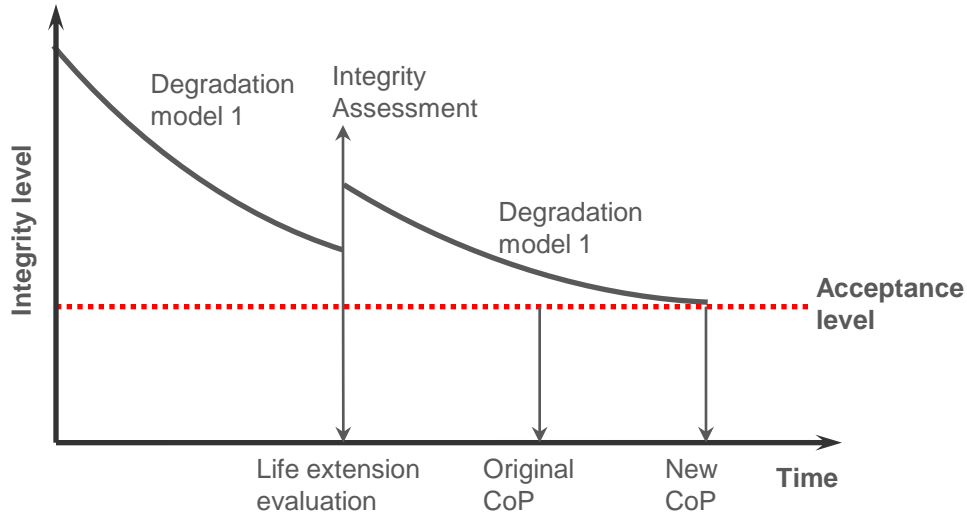
LE using same degradation model and Current condition assessment
[Norsok Y-002]

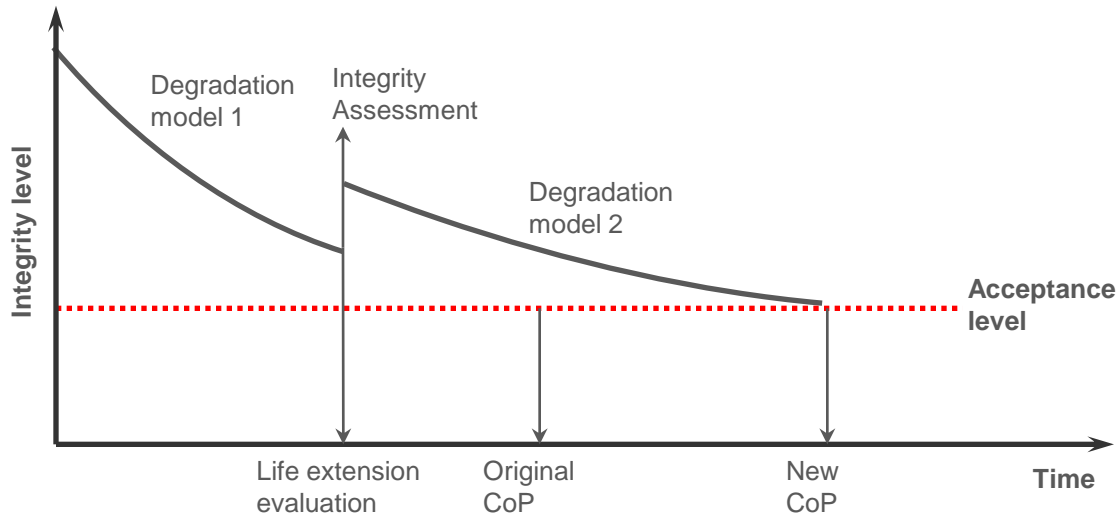
LE using new degradation model (new industry practice or operating conditions)
[Norsok Y-002]

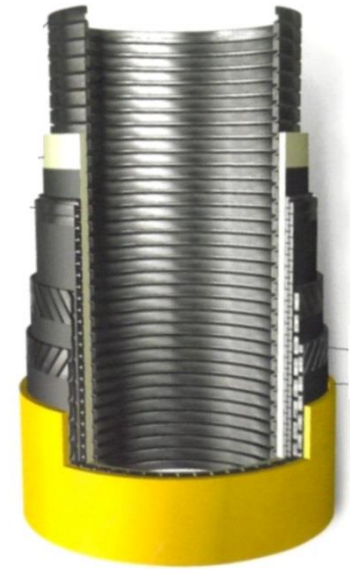
- Flexible risers
 - Multi-layered structures
 - Different materials / specific threats
 - Bespoke ancillary equipment
 - Some operate in harsh environment
- Life Extension
 - Mainly based on design / IMR data
 - Limited inspection methods
 - Main concern internal sheath / armour wires
 - Driven by accepted degradation models

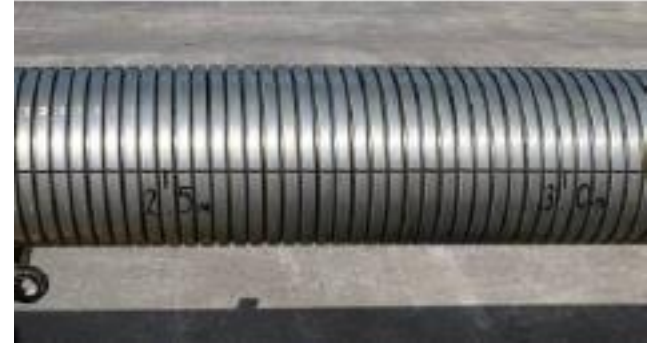
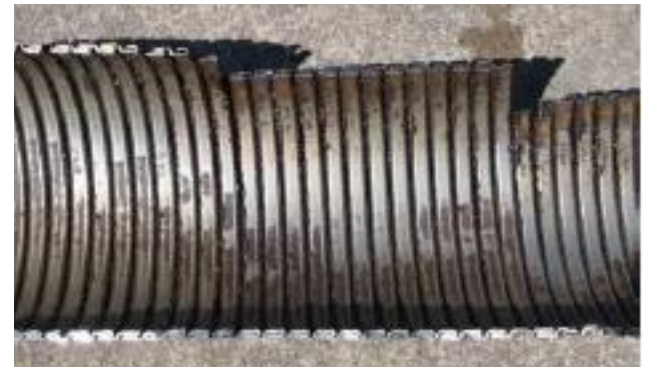
Carcass (Duplex)

- Credible life extension threats
 - Pitting (H_2S)
 - Thinning (erosion)
- PoF
 - Low (prod/gas, no carcass in WI)
 - H_2S < material limits, dry gas
 - Sand levels < design limits
 - Jumper dissection OK
- Recommendations
 - Ongoing IMR
 - Erosion calculations (target rate) to confirm when thickness will reach minimum allowable

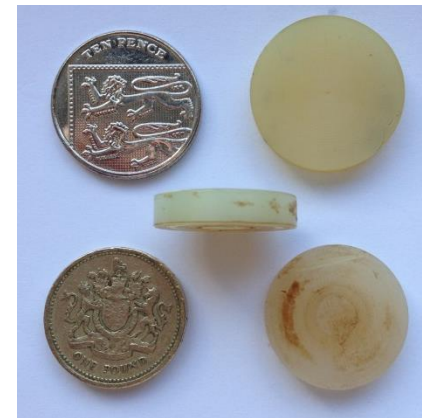
Pressure Sheath (PA-11, HDPE)

- Credible life extension threats
 - Ageing embrittlement
 - PA-11 (prod/gas): physical + chemical ageing
 - HDPE (WI): physical ageing only
- PoF
 - Low for prod/gas
 - Low operating t , 17TR2 analysis >100 years
 - Jumper dissection showed no concerns
 - Medium for WI (no coupons)
- Recommendations
 - Ongoing IMR
 - Ensure enough coupons until new CoP
 - Ageing validation for HDPE

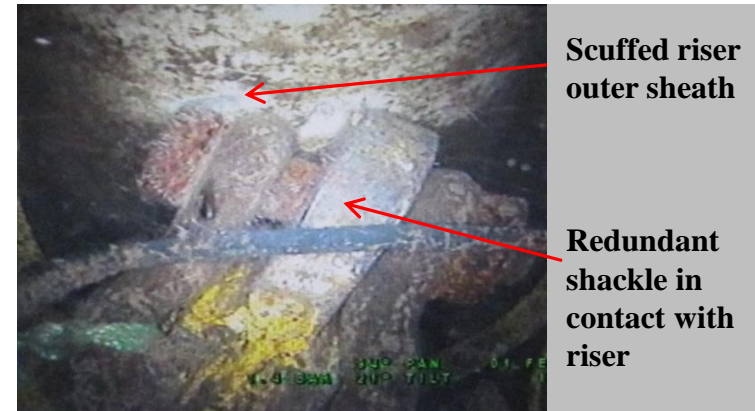
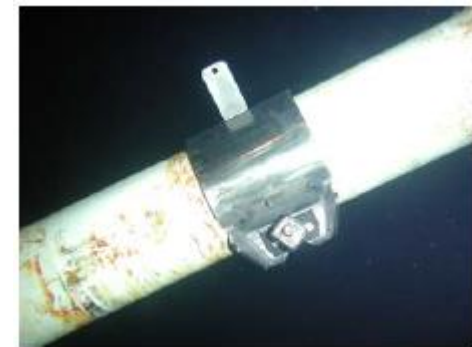
Armour Wires (Carbon Steel)

- Credible life extension threats
 - Fatigue (dry), C-F (flooded)
- PoF
 - Low (dry)
 - Fatigue life > 100 years
 - Medium (flooded)
 - C-F life = original CoP + 9 years
 - Known damage locations clamped
 - Minimal general wall loss expected (CI)
- Recommendations
 - Ongoing IMR (inc. repair clamps)
 - Remove redundant shackles
 - CP assessment

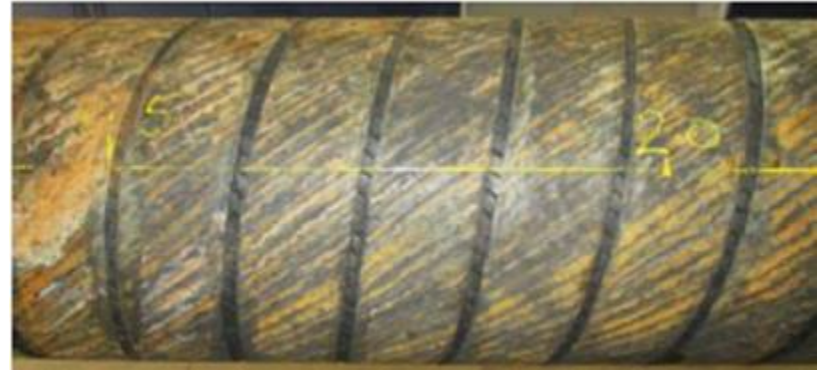
Anti Wear Tapes (PA-11)

- Credible life extension threats
 - Wear
 - Embrittlement (cracking)
- PoF
 - Low (>100 years)
 - Based on pressure sheath
 - Worst case flooded risers
 - Low operating bore t
 - Dissections showed wear not a concern
- Recommendations
 - Ongoing IMR

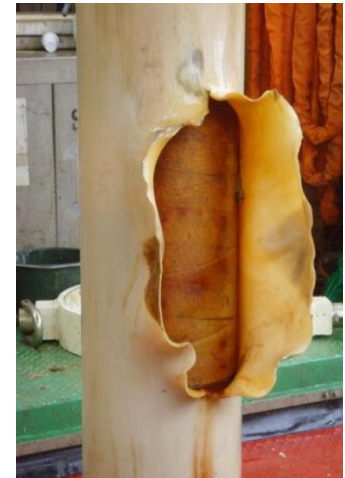
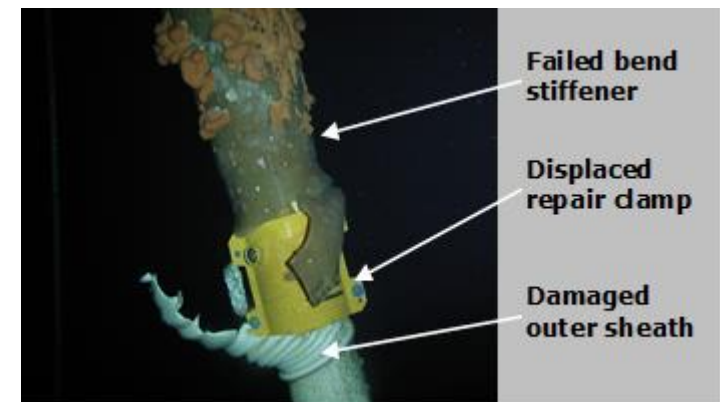
Outer Sheath (PA-11)

- Credible life extension threats
 - Rupture (inadequate venting)
 - Ancillary equipment failure
- PoF
 - Low (prod/gas, venting)
 - Regular RAVT / vent system CVI
 - Assuming shackles removed
 - Medium (all, ancillary equipment)
 - See ancillary equipment
- Recommendations
 - Ongoing IMR
 - Riser + ancillary equipment!

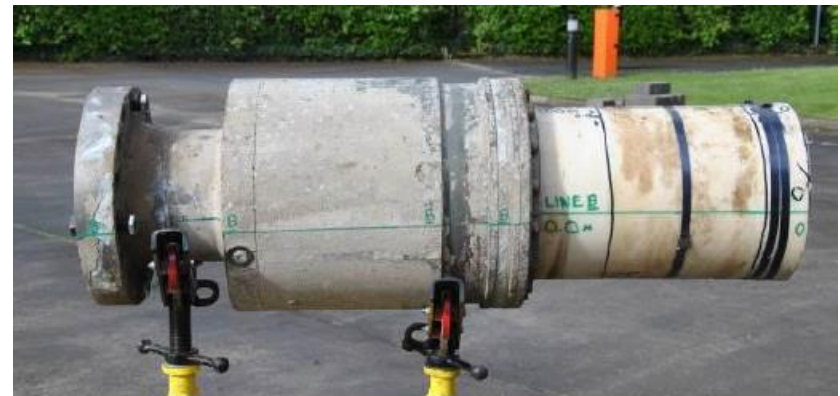
End-fitting

- Credible life extension threats
 - Marine corrosion
- PoF
 - Low
 - Ni-based coatings have proven to be effective
 - Industry experience shows no concerns
 - Dissections showed no concerns
- Recommendations
 - Ongoing IMR

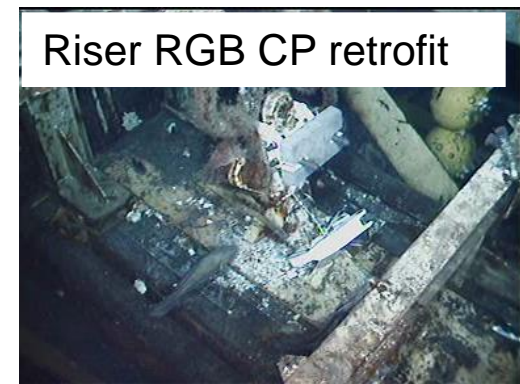
Ancillary Equipment

- Credible life extension threats
 - Corrosion / fatigue
- PoF
 - Medium (hold down/back system)
 - Historical CP issues (all rectified)
 - Fatigue assessment only until CoP
 - Low (RBS + support wires)
 - Sufficient fatigue life for RBS
 - Regular replacement of wires
- Recommendations
 - Ongoing IMR
 - HD/HB fatigue assessment using new MetOcean data

- Key considerations (cont'd)
 - IMR
 - No reduction assumed in capability to monitor, assess, and maintain the risers (PoF impact)
 - Any major change in operating/environment conditions will require LE revisit (degradation model)
 - Riser ancillary equipment
 - RBS cannot be repaired in service
 - Consider fatigue life in conjunction with riser fatigue life
 - CS repair clamps may require CP retrofits / change-out
 - CP system
 - Option 1: anode assessment + CP retrofits
 - Option 2: GVI/CP + repair clamps

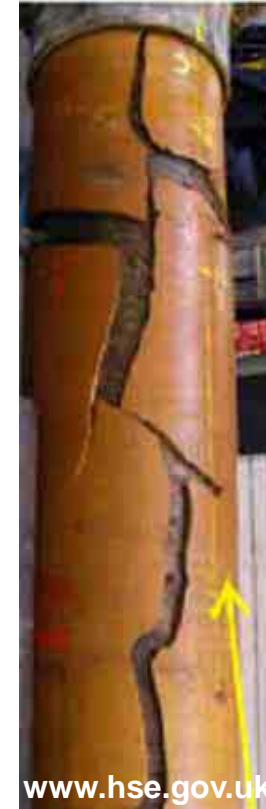
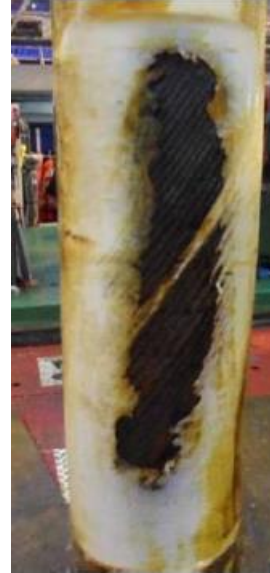
- Other possible LE threats
 - External sheath embrittlement
 - Insulation from RBS / clamps
 - Ageing → cracking
 - Mitigation: improved design/material
 - Marine Growth
 - Reduced buoyancy (LP coral, 3 Te/m³)
 - Altered catenary → sheath damage
 - Mitigation: GVI + MG removal
 - Outer sheath abrasion
 - Abrasion at J-tube exit / touch-down
 - Annulus flooding → reduced fatigue life
 - Mitigation: GVI / improved design
